**A REPORT ON THE TERRESTRIAL ASSESSMENT OF
TSUNAMI IMPACTS
ON THE COASTAL ENVIRONMENT IN
REKAWA, USSANGODA AND KALAMETIYA (RUK) AREA OF
SOUTHERN SRI LANKA**

February 2005

**IUCN – The World Conservation Union
Sri Lanka Country Office
53, Horton Place, Colombo 7.**

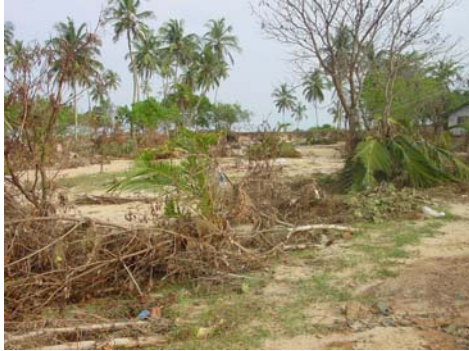
Signs of severe erosion in beach front areas

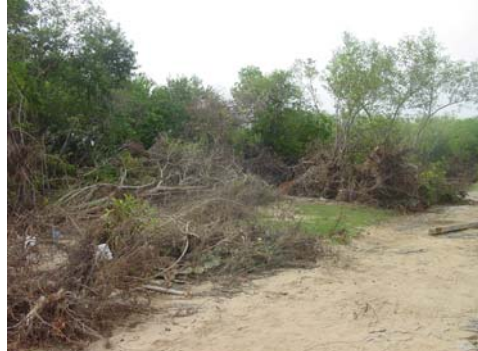
In Medilla (site 1), the impact on mangrove vegetation close to the estuary facing the sea showed severe damage to both ground habitat (score 3.9) and mangrove trees (score 3.4) with an average impact score of 3.6. This severe damage has resulted from the funnelling of sea water through the artificial canal. However, the strip of mangrove vegetation (site 2) located about 100m behind the site 1, and shielded by a thick and broad mangrove stand showed low damage, with an average damage score of 1.4. This highlights the buffering effect of front line mangroves, which has minimized the damage interior. The mangroves close to the estuary have trapped most of the rubble and debris.

Destroyed mangroves bordering beach front areas

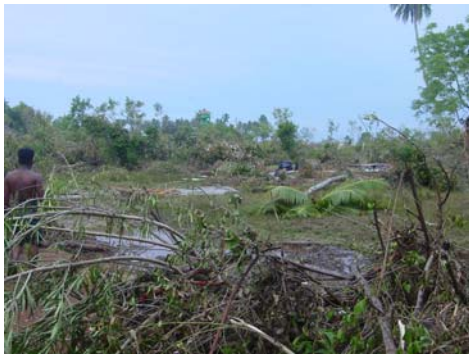
A location subjected to funneling of sea water, and penetration through a thin mangrove stand

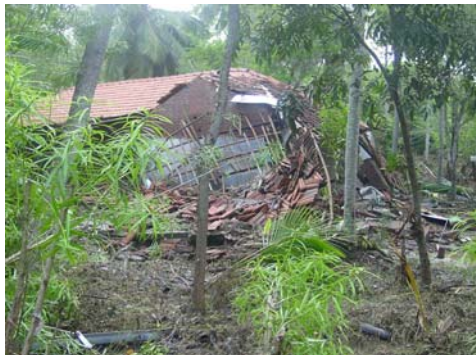
Damage in settled areas behind a thin mangrove strip

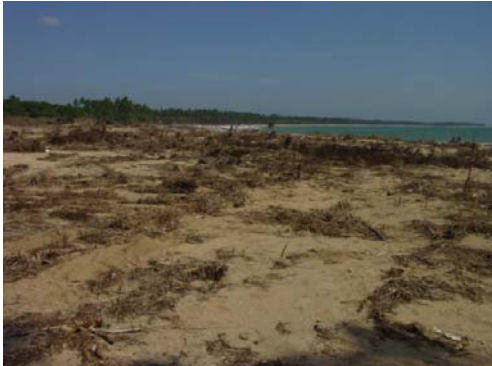
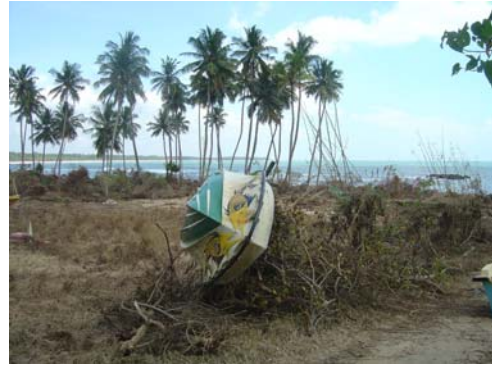
The damage to habitats in the exposed Oruwella harbour area (site 5) was severe, as evident from the alterations caused to the ground (score 3.9) and damage to mangrove trees (score 4). A near-shore fringing coral reef is located about 50m away from the beach in this area, which is in a highly degraded status due to mining and bottom set netting.

Destruction of scrubland and home gardens located behind an exposed beach area

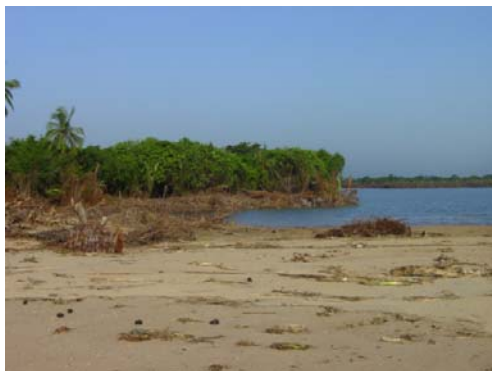
Nipa dominant mangrove destroyed and sand deposited in estuary mouth

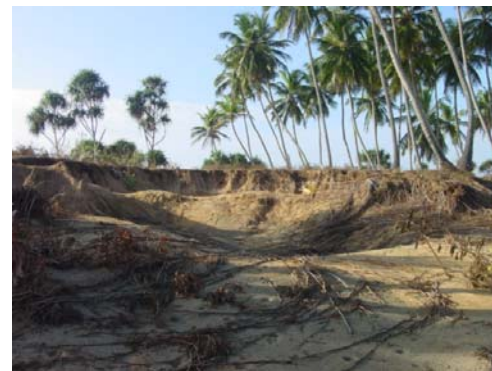
Severe erosion in coconut plantation at beach front

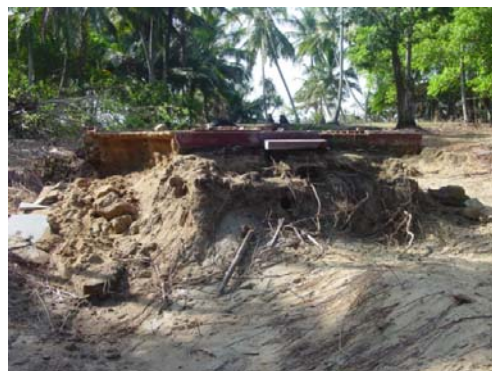
Completely destroyed house in the beach front

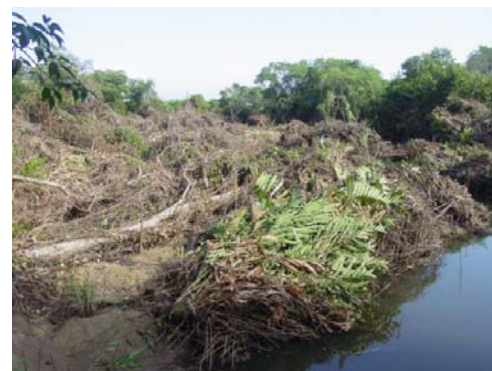
Structural damage to mangrove trees in the frontline

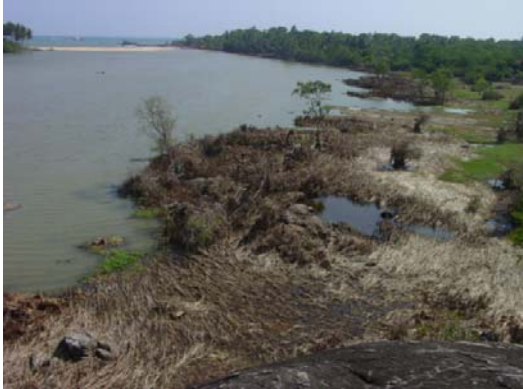
Damaged vegetation bordering a lagoon due to funneling of sea water

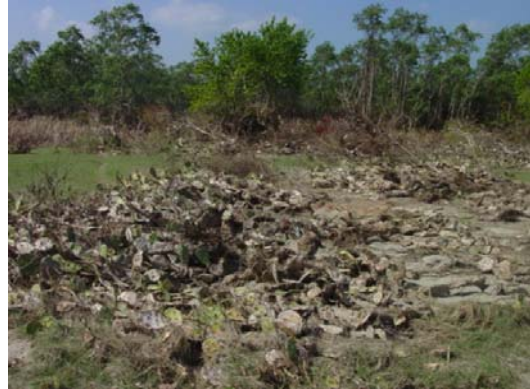
The invasive alien Prickly Pear Cactus (*Opuntia dillenii*) that occurred in the beachfront habitats have been removed and transported to distant inland areas by the Tsunami waves, and these propagules have now started to establish in new areas. The spread of another invasive alien plant – Mesquite (*Prosopis juliflora*), which is already prevalent in the RUK area, may increase rapidly over time, as it exhibits a competitive dominance under increased saline conditions. Freshwater invasive alien species such as Cattail reed (*Typha angustifolia*) and Water Hyacinth (*Eichhornia crassipes*) occurring in low-saline lagoons such as Kalametiya have been destroyed due to increased salinity. Many individuals of free-roaming domestic cats and dogs were observed in the RUK area subsequent to the Tsunami, and these may form feral populations in the future

Invasive alien *Opuntia* transported inland by the tsunami water

- Propagules of the invasive alien Prickly-pear cactus (*Opuntia dillenni*) carried into interior areas by the Tsunami waves should be collected and burnt.

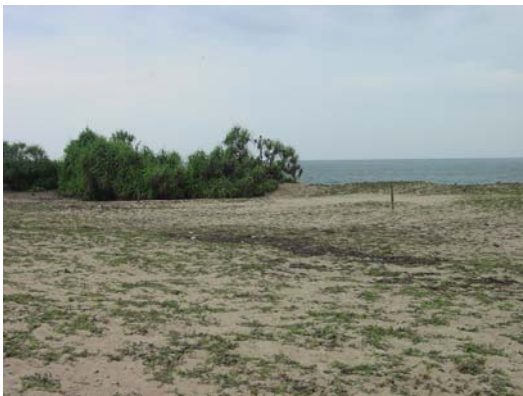
Broad and high sand dune stabilized with dune vegetation – very low tsunami impact

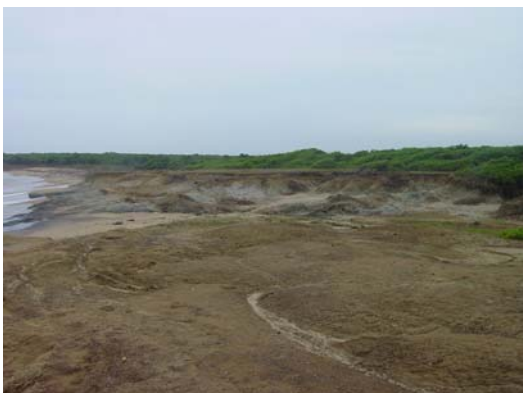
Signs of erosion

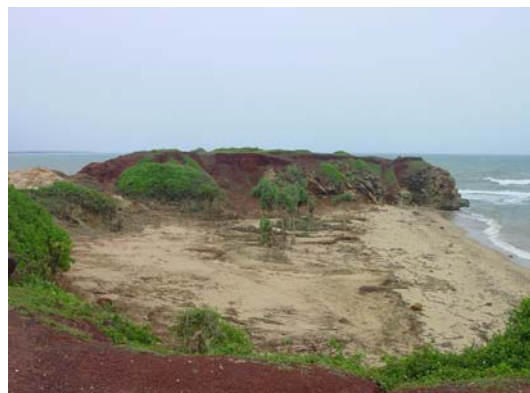
Destroyed *Pandanus* stands, eroded beach and deposited coral debris on beach

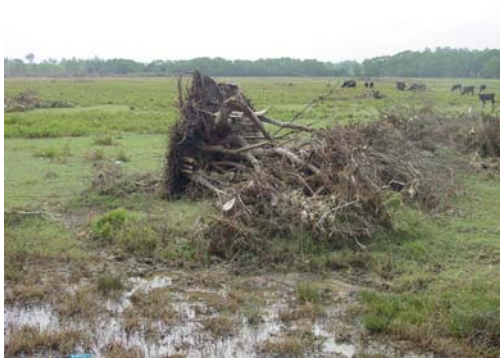
Avicennia tree clumps uprooted and transported 75m inland with the wave and deposited on the salt marsh

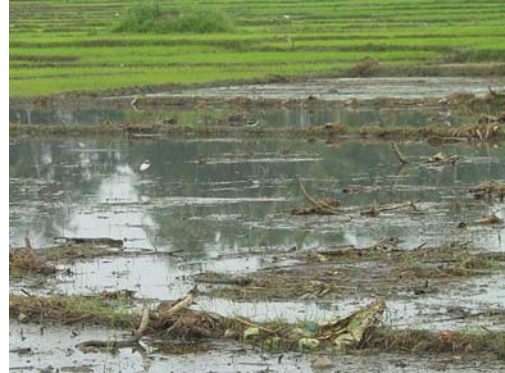
Mud deposition and salt water intrusion in to paddy land

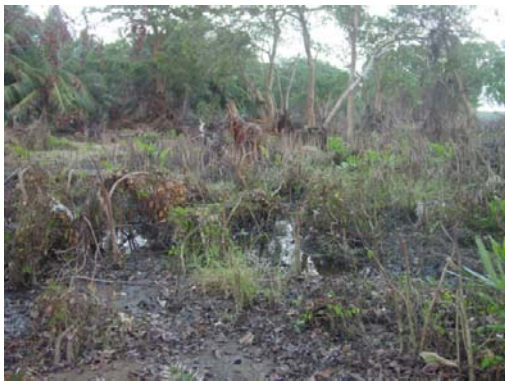
The mixed mangrove system (site 12) located parallel and closer to the Walawe river and beach in Wanduruppa area showed a high impact to both trees (score 3.5) and ground habitat (score 3.7) with an average score of 3.6. Removal of large Kumbuk trees (*Terminalia arjuna*) of riverine vegetation and thinning of the mixed mangrove strip due to human encroachment in the recent past has probably enabled tsunami waves to cause heavy damage in this area.

Structural damage in the mangrove stand at the frontline

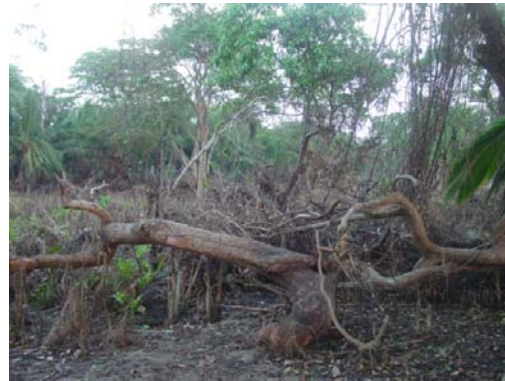
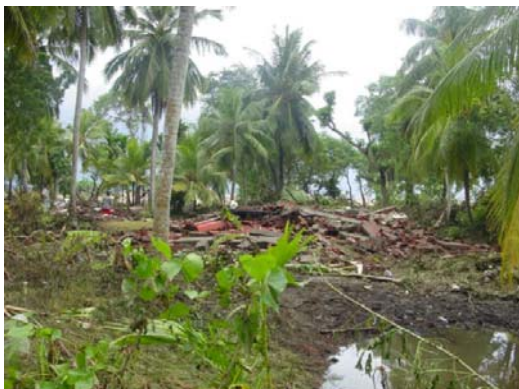
Damaged human settlement at the Wanduruppa village behind the thin mangrove stand

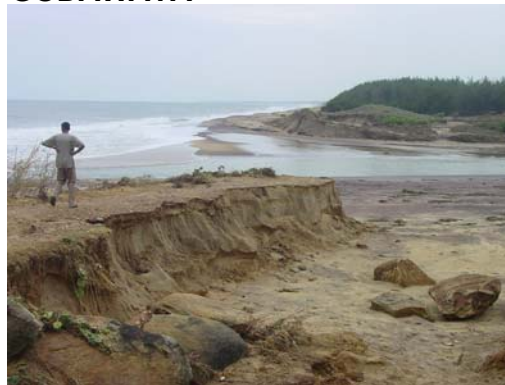
Signs of severe erosion

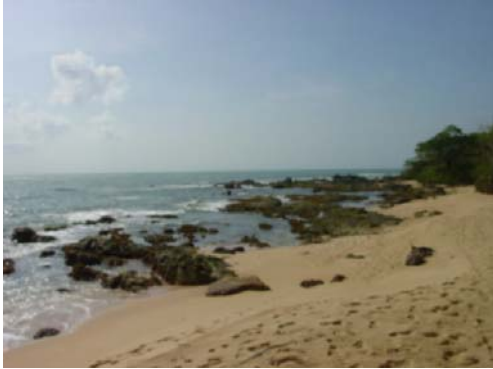
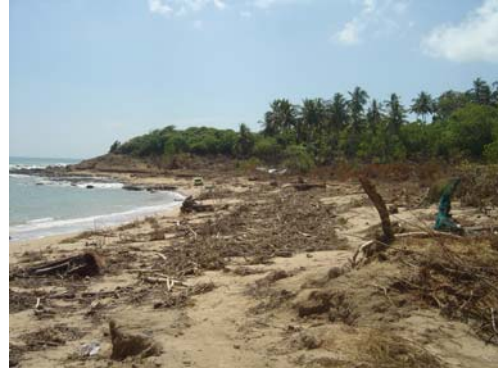
PRE TSUNAMI
Narrow and steep beach with rocky shore

POST TSUNAMI
NOTE: Same location with wider angle

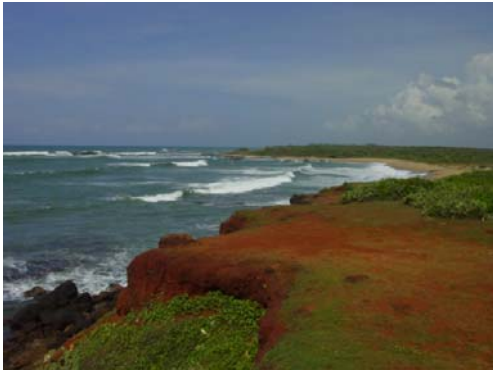
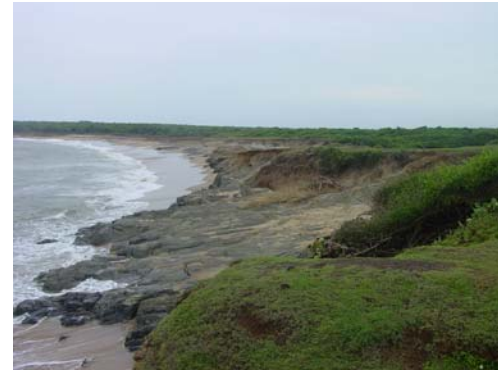
POST TSUNAMI
Signs of erosion in bank of the cliff
NOTE: The photograph was taken from a low angle than the pre-tsunami one

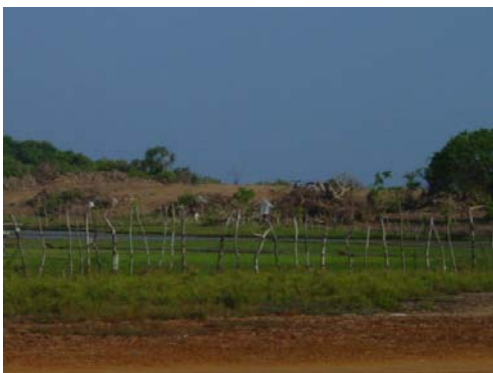
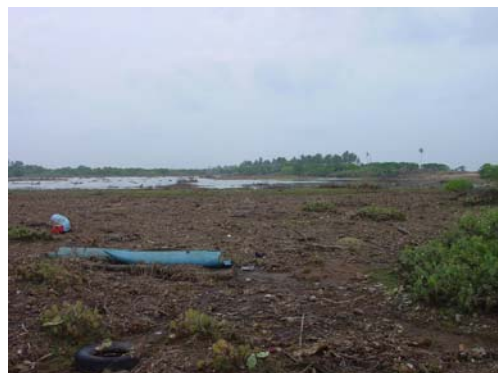
The scrubland vegetation (site 11) behind the Ussangoda fishery harbour beach showed an extremely high damage to both ground habitat (score 3.8) and woody plants (score 3.4) with an average 3.6 impact on the habitat. This is an area where the beach scrub vegetation was cleared and the sand dune was exploited prior to the tsunami.

PRE TSUNAMI
Beach front scrubland cleared

POST TSUNAMI
Water have funneled inland through the cleared area in to low land

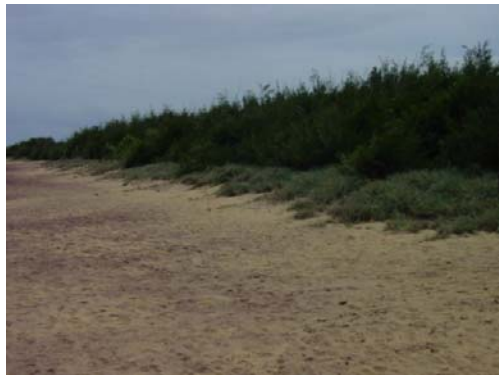
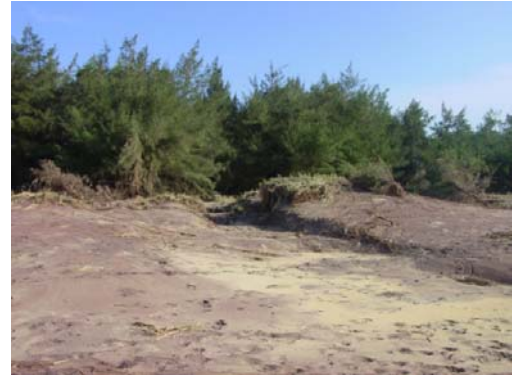
With signs of erosion and damage to low lying vegetation at beach front

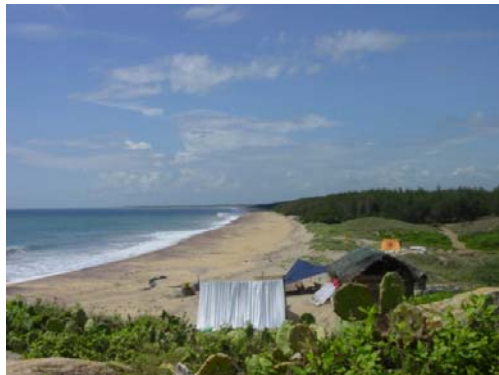
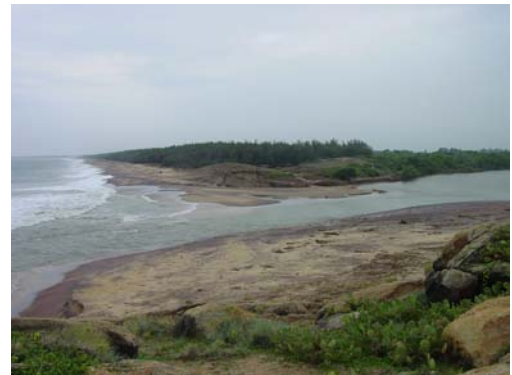
Permanent sand dune separating sea and the estuary, with dry fish processing shed on the dune

Dune is broken and the old river mouth re-opened
